# Fridge weekly report

12/07/2012-12/13/2012

T. O'Donnell

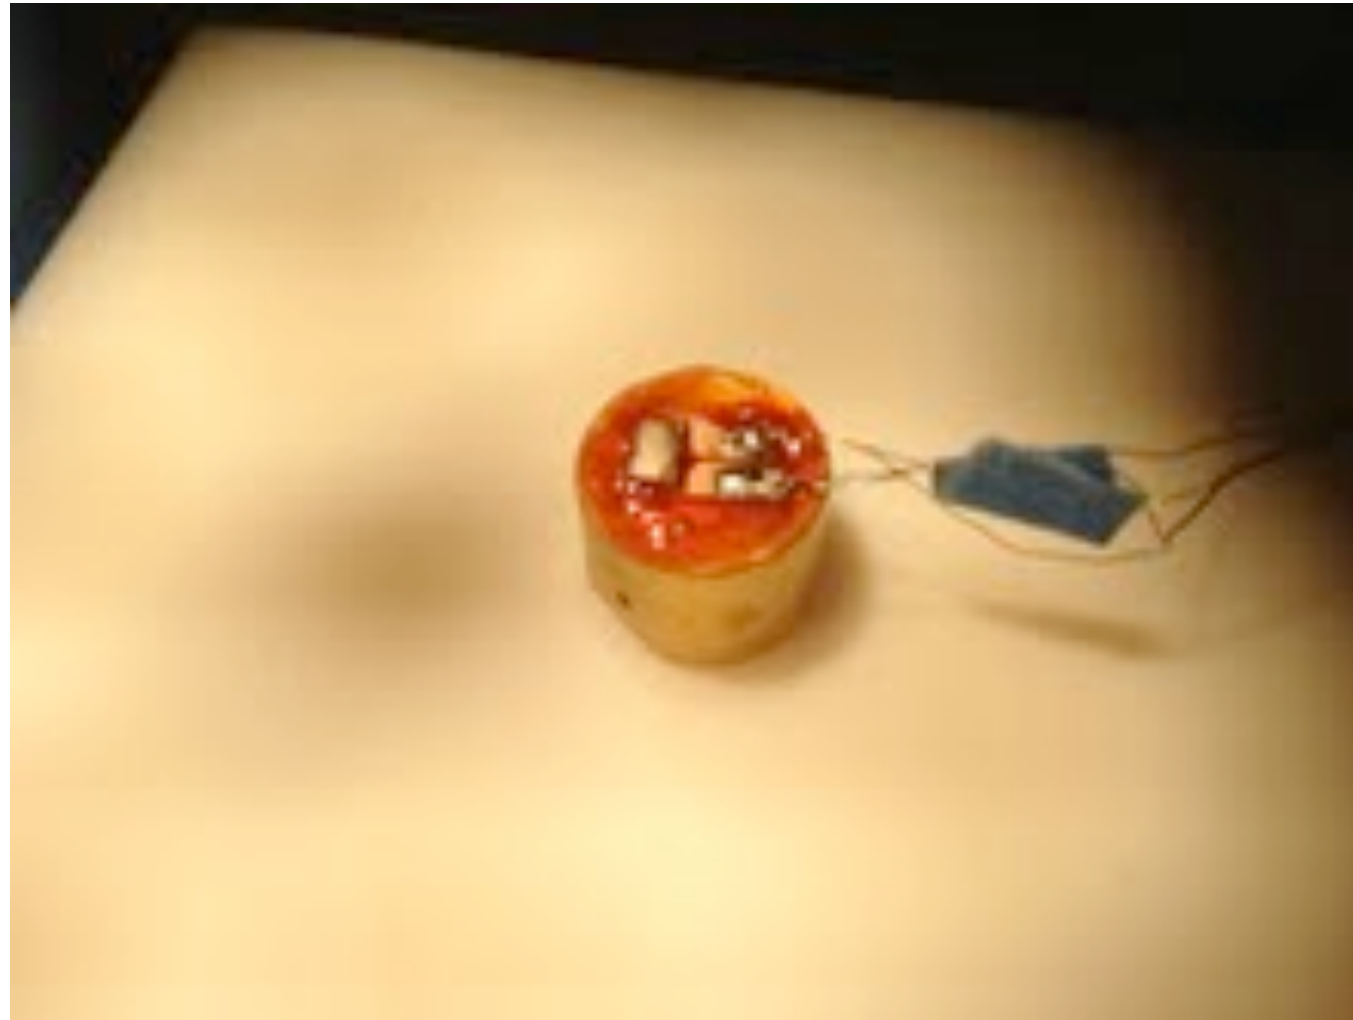
# Resistor-heater setup

50 kOhm NiCr resister on alumina substrate

Kypton PCB varnished to puck

Resister held with varnish on Kypton PCB, setup for 4-wire measurement

Mounted on EP, but found problem with channel 6 of conn I

Can do a two wire measurement
